Not just the cladding... The Grenfell Tower Fire: Understanding what happened

Here Gill Kernick offers a dispassionate summary of the chain of events leading to the deaths of 72 people in the Grenfell Tower Fire on the 14th June 2017. It is based on expert evidence presented to the Public Inquiry in November 2018.

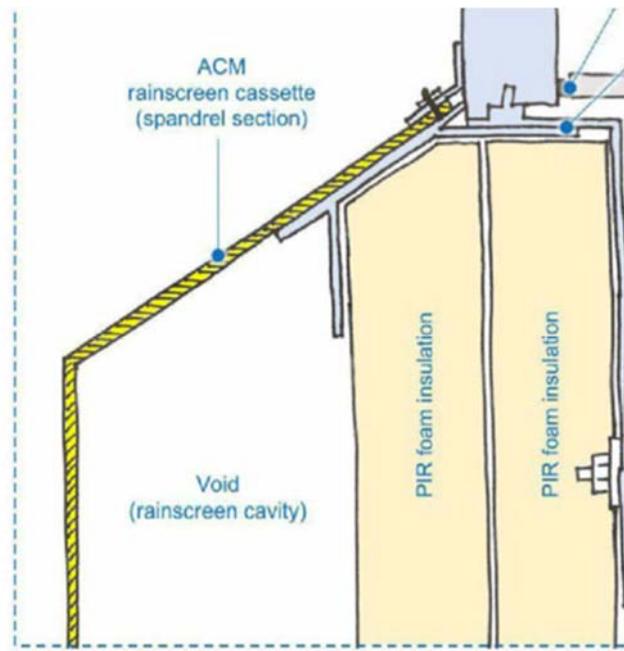
Figure 1: Cladding System^{vii}

The rainscreen cladding system (Figure 1) that was added to the building during the refurbishment was comprised of

- two layers of polyisocyanurate (PIR) foam insulation against the original concrete walls
- a cavity separating the insulation from the
- Aluminium Composite Material (ACM) panels or cassettes which were comprised of two thin aluminium panels with a polyethylene (PE) core. (Figure)

Thermoplastics such as PE melt and drip and burn. Prof Bisby said that PE was the main cause of the fire spread and that the dangers of using such materials were well known and had been documented for decades. He would have expected any competent fire professional to be aware of these dangers.

Each cladding panel was cut and folded to hang on metal rails. This led to their being multiple routes where the PE was exposed directly to heat and flames. The metal rails enabled pooling of melted PE.

In addition, the way these panels and the windows were connected to the original façade meant that there were numerous vertical channels and extensive internal cavities. Horizontal and vertical barriers were installed in the cladding cavity, intended to isolate any fire. Some of the barriers were missing or incorrectly installed.

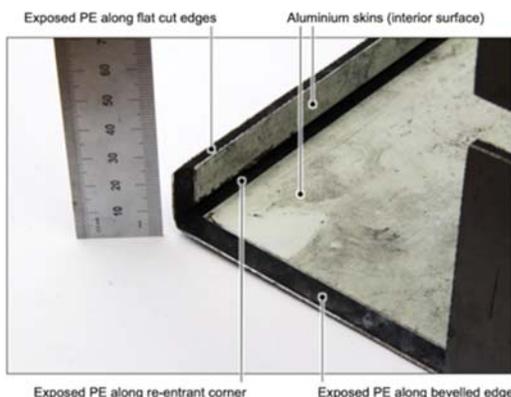
Figure 2: ACM panels or cassettes^{viii}

European Standards for Fire Testing rate materials from A1 – non-combustible - through to F – which are ‘really burny’ (to use the words of Ms Grange (QC)). Current Regulations require cladding systems to be at a minimum of limited combustibility - A2. According to Dr Lane the PIR insulation was European Class D and the ACM panels European Class E.

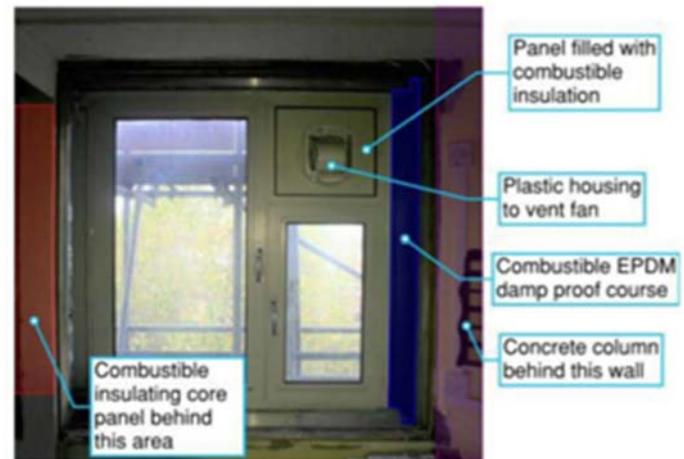
Figure 3: Windows^{ix}

Windows (Figure 3) were reduced in size during the refurbishment and moved to sit flush with the new cladding system. The old wooden window frames, sills and other materials were left in-situ. The new window frames and the extractor fans [set into the windows] were made of unplasticised polyvinyl chloride (uPVC) and were glued rather than fixed into position. uPVC melts at low temperatures.

Extruded polystyrene (XPS) was shaped and covered in aluminium foil to fill gaps around the extractor fans and was used in the infill panels placed between the windows. XPS melts rapidly forming burning droplets.

Phenolate Foam (PF) and spray foam was used in small quantities near the windows to fill drafts and gaps. PF is flammable, and it is possible that the foam was the first material to ignite.

An ethylene propylene diene monomer (EPDM) rubber membrane was used to cover the gap between the window and the wall. It too is flammable and once alight would allow a fire access to the cavity. Dr Lane said you could cut a hole into the EPDM and put your hand into the cavity.

The materials around the windows were glued together and led directly into the cladding system on the outside of the building. Dr Lane said that building regulations require that cavity barriers should be placed around the windows to stop the spread of fire. None were present at Grenfell either in the design drawings or the building itself.

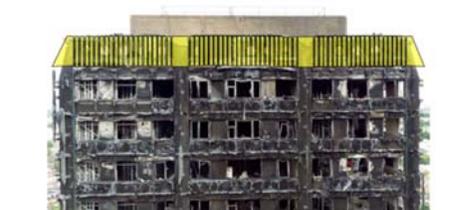
Figure 4: Architectural Crown^{xi}

A crown (Figure 4) was installed at the top of the building comprised of ‘folded’ ACM cladding. Its purpose was purely architectural. Exposed edges of PE were found everywhere in the crown.

Prof Bisby said that in other cladding fires you tend not to see entire buildings engulfed. The distinguishing feature in this seems to have been the architectural crown which, as described earlier, was made of ACM panels with multiple folds exposing the PE. The flames appear to have been able to travel horizontally in both directions through the crown. The crown was almost acting as a fuse.

'the only way to stop the crown from being a flame front on its own is to not clad it in combustible material'^{xxii}

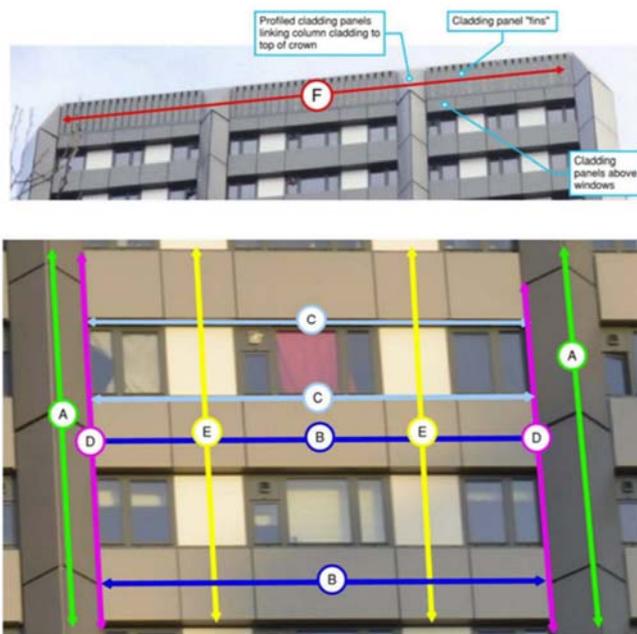
Figure 5: The 6 routes of fire spread^{xix}

The materials, numerous cavities and metal railings created routes for the fire to spread vertically and horizontally. Dr Lane identified 6 routes that the fire took, she wanted to show that *'at every turn there is something there that can participate in a combustion process, so all the time the flame front had something that would allow it to carry on'*^{xviii}

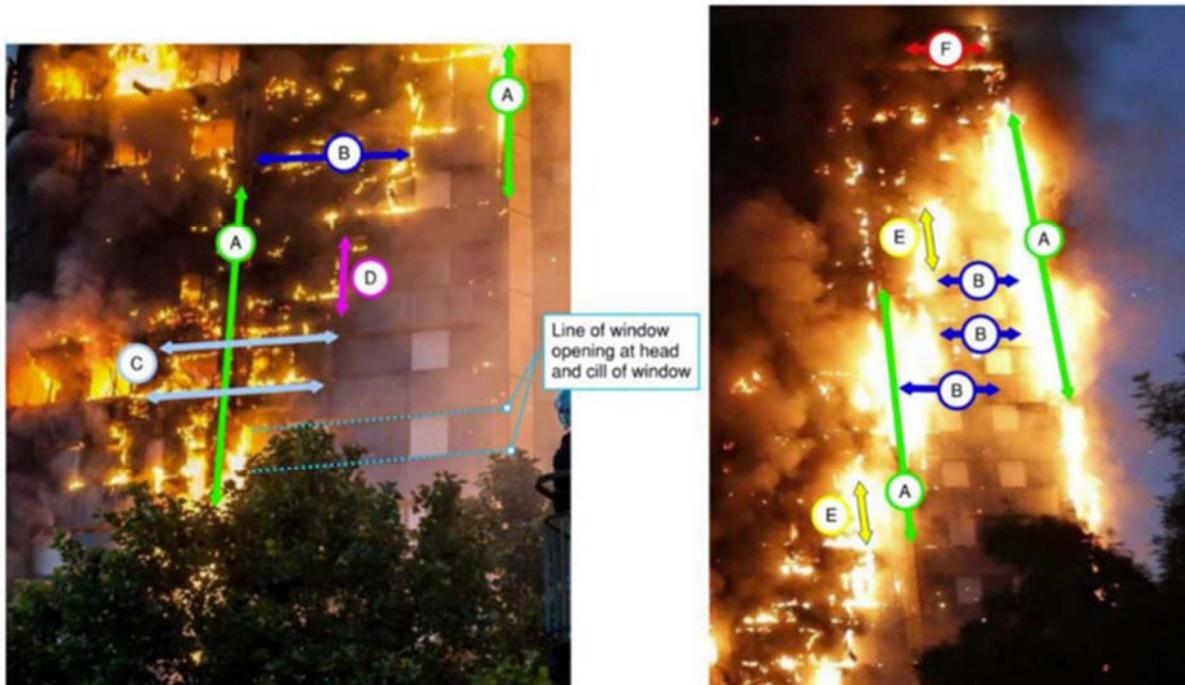
Figure 6: Photographic evidence of the 6 routes of fire spread^{xxi}

The helicopter footing (Figure 6) shows the flame front progressing and causing extensive pools of burning PE which could then flow down the spandrels and columns. This pooling and dripping of the PE together with burning debris enabled the fire to spread down below the upper floors.

The fire spread rapidly laterally around the crown and engulfed the building as the PE melted and dripped and the lower fires made their way up the building.

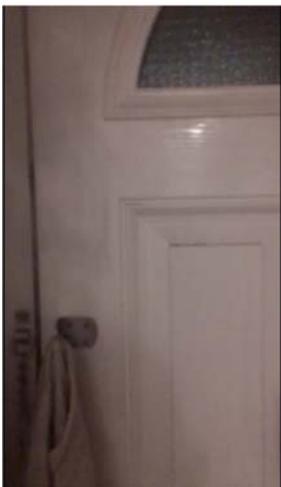
Figure 7: Conditions inside^{xxiv}

There was heavy damage to the lobbies and symptoms of high temperatures in the stairwell. Thick black smoke in the lobbies and stairs created a barrier (both physical and psychological) to residents and their ability to move from their flats. Poor visibility and irritants when they opened doors were a significant deterrent to escape.^{xxiii}

Figure 7 provides a link to a video from Marcio Gomez's flat on the 21st floor. As they open the door, it shows thick black smoke with zero visibility. A white wall was approximately 1 meter away. Mr Gomez, his wife and two daughters escaped the building. Their unborn son Logan Isaac was the youngest victim of the fire.
